Manhole Inspection Summary

Manhole # S33A__003MH

Insp Date: **8/19/09 11:42 AM**

Location Address: **100 HAMILTON ST**

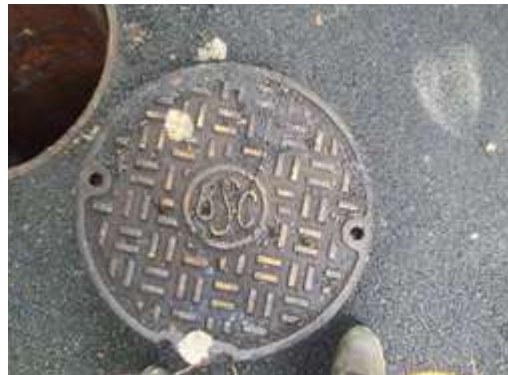
Defect 3

Condition: **Cracked**

CRACKED LID

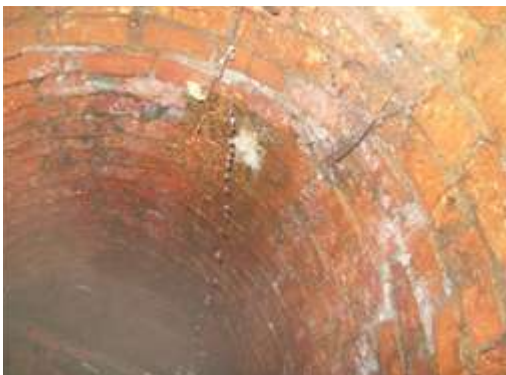
Defect 2

Infiltration: ☐ None ☒ **Joint** ☐ Cracks ☐ Mortar ☐ Roots ☐ Wall

LEAK @ MORTAR JOINT

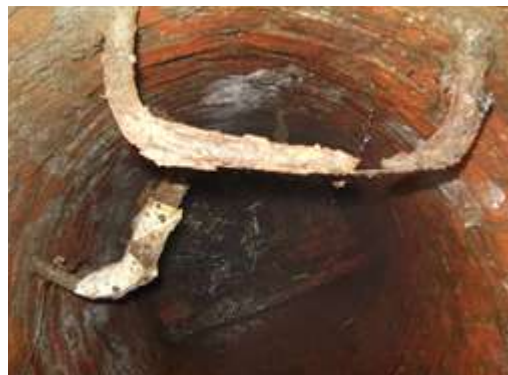
Defect 1

Count: **7** Missing: **0** ☒ **Corroded**

CORRODED STEPS

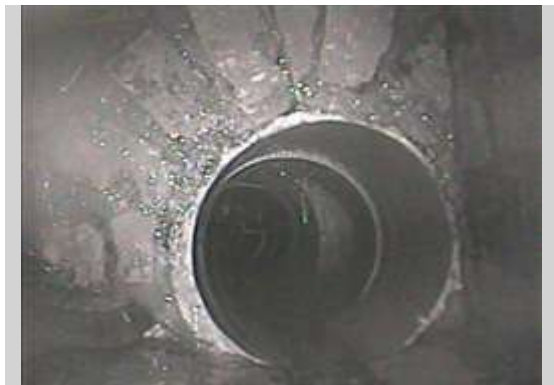
12 O'Clock Outflow

10 in. Circular Gravity Sewer
Pipe Out @ 12 O'Clock

Infiltration: **None** Pipe Seal Cond: **Sound**
